1. Purpose and scope of this memorandum

This memorandum summarizes a site survey performed July 5, 2018 to evaluate the condition of ADA mandated access at Little Sandy Park in Pembroke Massachusetts. After a description of the site and site uses, recommended improvements are provided in Section 7, beginning on page 2.

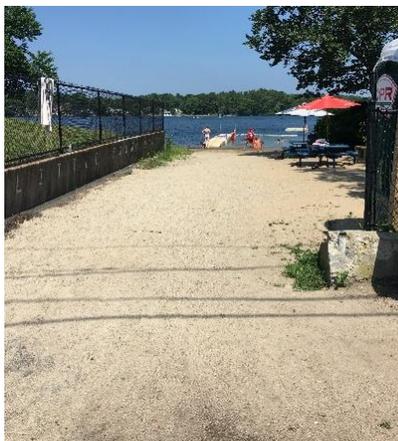
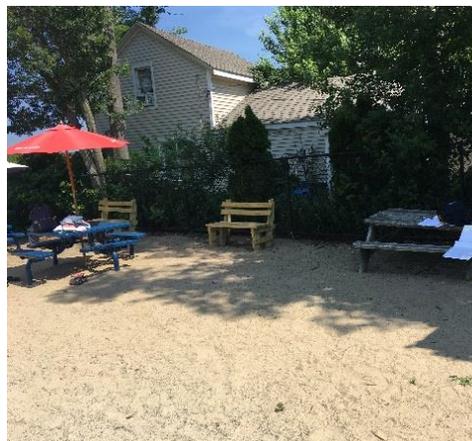
Little Sandy Park comprises of an unimproved sand strip, approximately 32' wide, connecting the paved portion of Woodbine Avenue to Little Sandy Pond. A single portable toilet is placed at the northeast side of the sandy area. A small equipment building is located approximately 20 feet from the paved portion of Woodbine Avenue. No on-street parking is indicated in the vicinity of the Park. Three picnic tables and two wooden benches are located on the northern side of the sandy area. The benches sit parallel with a black vinyl chain link fence that separates the sandy beach area from the adjacent neighbor's property. The distance from the paved street to the water is approximately 105'. There is a floating dock with a ramp connecting to the beach. The dock is 5' wide, parallel with the southern property line and extends approximately 50' out into the pond.

Parking for Little Sandy Park is on-street with spaces for perhaps 3 vehicles. No parking stalls are marked; no handicapped spaces are indicated. The restroom facility provided is not ADA compliant. No emergency telephone is provided.

- a. Short term site improvements for accessibility would include running a removable beach mat from the paved street to the normal recreation water level of the pond.
- b. The current portable toilet on site is not ADA compliant. It is recommended to update this to an ADA compliant portable restroom and provide an ORAR, whether is it a mat or one of the other acceptable surfaces, to the compliant restroom.
- c. An option for short term improvements to address the accessible parking space would include paving one space with room for an isle and add line striping indicating that handicap space. Access from the accessible isle to the ORAR is required.
